PHASE 1 ENVIRONMENTAL SITE ASSESSMENT LOT 1, BLOCK 1, PLAN 102 4120

WITHIN SW 1/4 5-70-6-W6M
MUNICIPAL DISTRICT OF GREENVIEW NO. 16, ALBERTA

PREPARED FOR
HIGHGROVE HOLDINGS INC.
GROVEDALE, ALBERTA

PROJECT No.: GP3760

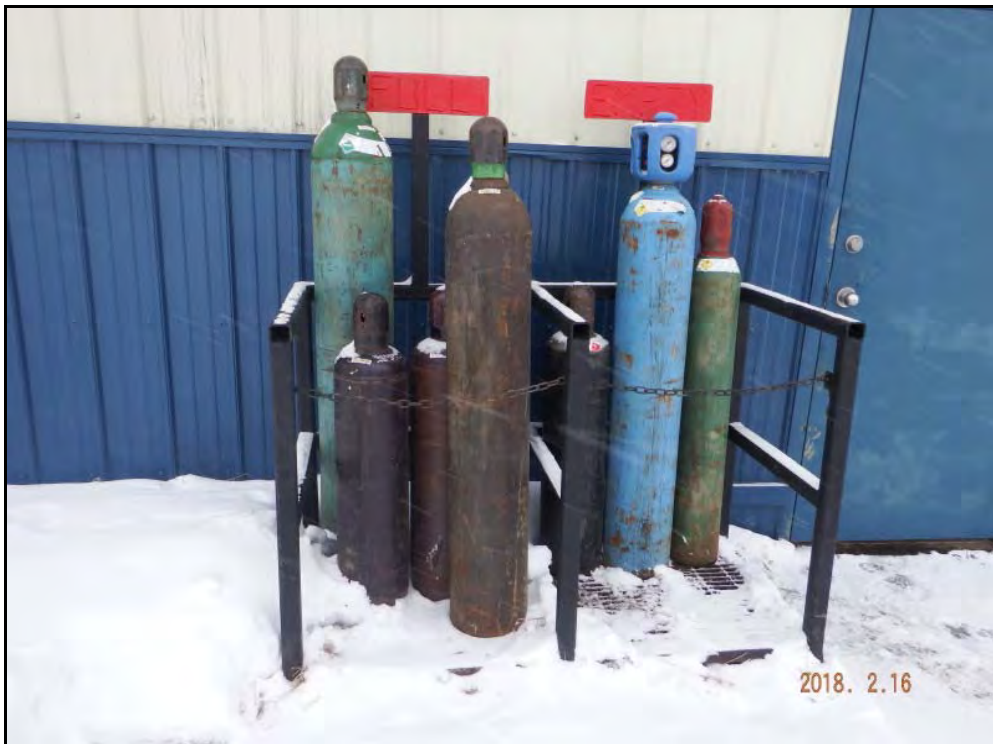
Photograph 6: Compressed gas cylinders observed near the west side of the building.

Compressed gas cylinders were observed in the yard along the west side of the building and within the building (Photographs 6 and 33). Cube storage containers were stored along the eastern side of the yard. Mr. Friesen stated that the contents were a herbicide used to stunt aspen tree growth to allow spruce to grow after logging and replanting activities and were spread by helicopter during the summer. The potential environmental risk to the Property from the cube storage containers is considered to be low.

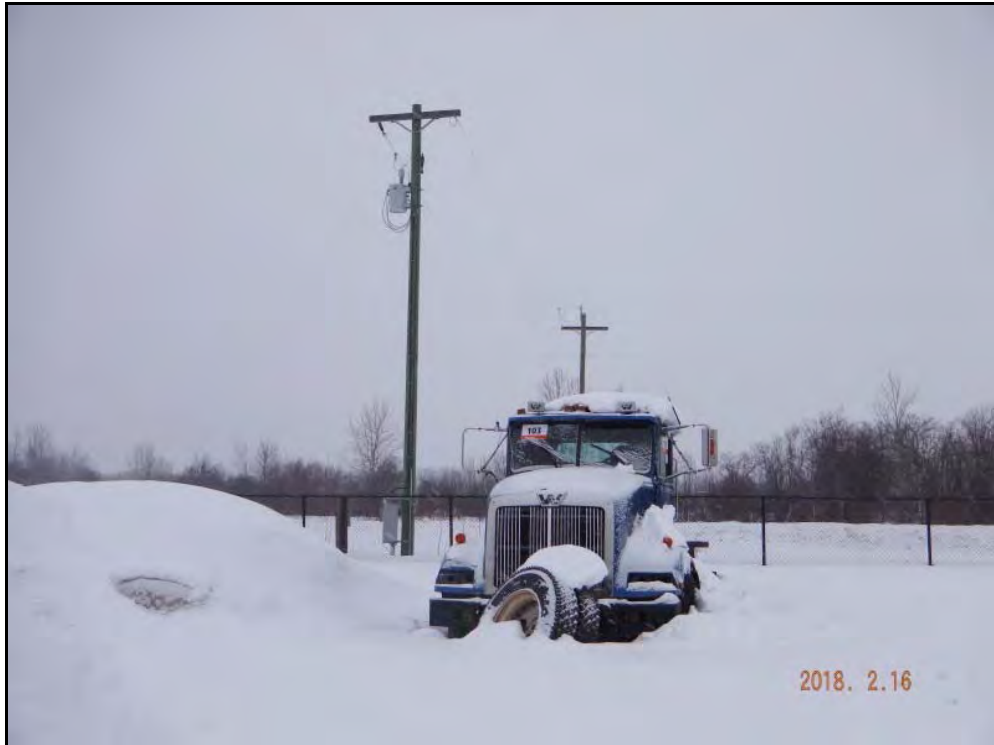
Photograph 11: Transformer observed north of the Property.

A transformer was observed on a hydro pole north of the Subject Property. The transformer appeared to be in good condition and no signs of damage or leaks were observed (Photograph 11). Contamination resulting from the transformer would be the responsibility of the utility owner.

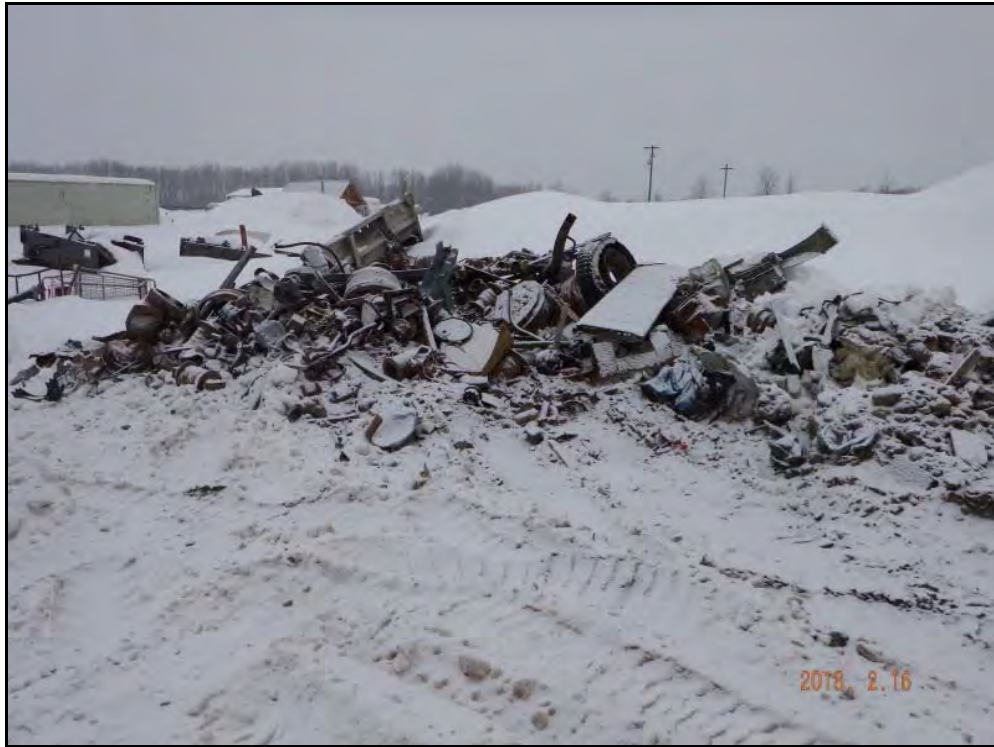
Photograph 19: Stockpile of debris observed near the center of the yard.

No fill was observed on the Property, however, several piles of snow were present across the Site and a stockpile of debris was observed in the center of the yard (Photographs 19 and 20). It is recommended that the pile of debris be removed from the Site. If any staining that extends beyond 300 mm is observed once the debris is removed, soil sampling is recommended.

- A stockpile of debris, which included metal items, was observed near the center of the yard. It is recommended that all debris be removed from the Property and disposed of properly. If any staining is observed once the debris is removed that extends beyond 300 mm, soil sampling is recommended.

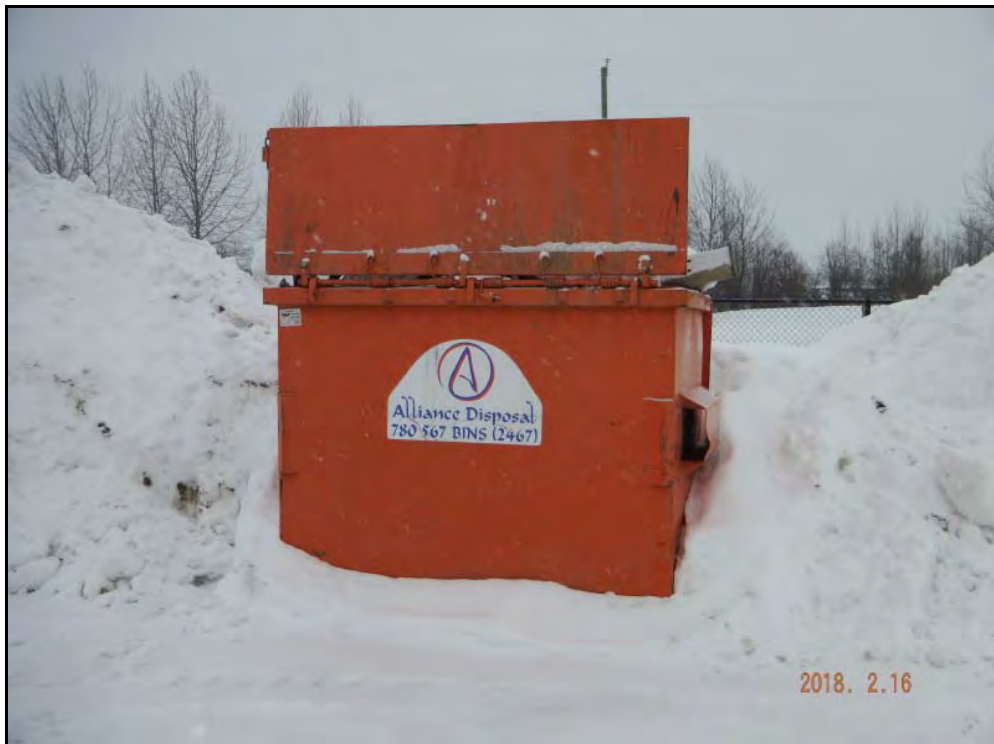
Photograph 22: Alliance Disposal dumpster located on the northeastern side of the yard.

An Alliance Disposal dumpster was observed in the northwestern side of the yard (Photograph 22). Mr. Friesen stated that a septic holding tank was used on the Property.

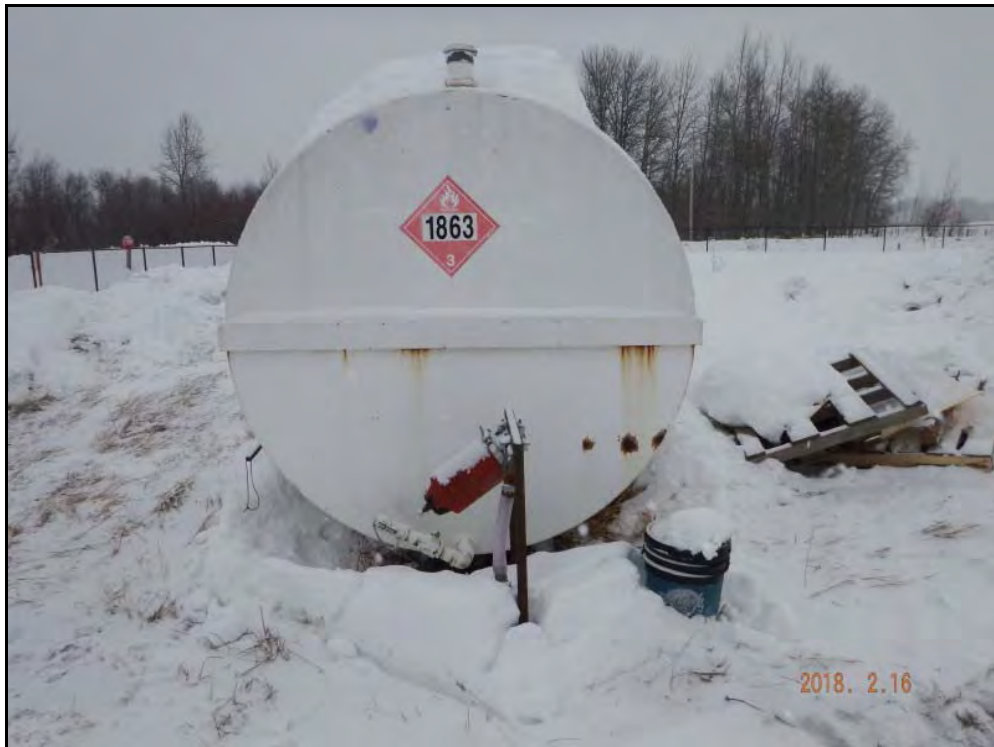
Photograph 23: UN#1863 (fuel, aviation, turbine engine) tank observed on the northeastern side of the yard.

A UN#1863 (Fuel, aviation, turbine engine) tank observed near the northeast side of the Property was used to fuel helicopters in the summer and was installed approximately 3 years ago (Photographs 23 and 24). Empty small storage tanks labeled UN#1202 (diesel fuel) were stored throughout the Site (Photograph 15). The Property was serviced by an underground septic tank system. Mr. Friesen was not aware of any other aboveground or underground storage tanks on the Property. The potential environmental risk to the Property from the ASTs and septic UST was

considered to be low to moderate. It is recommended that the UN#1863 tank be registered with the PTMAA.

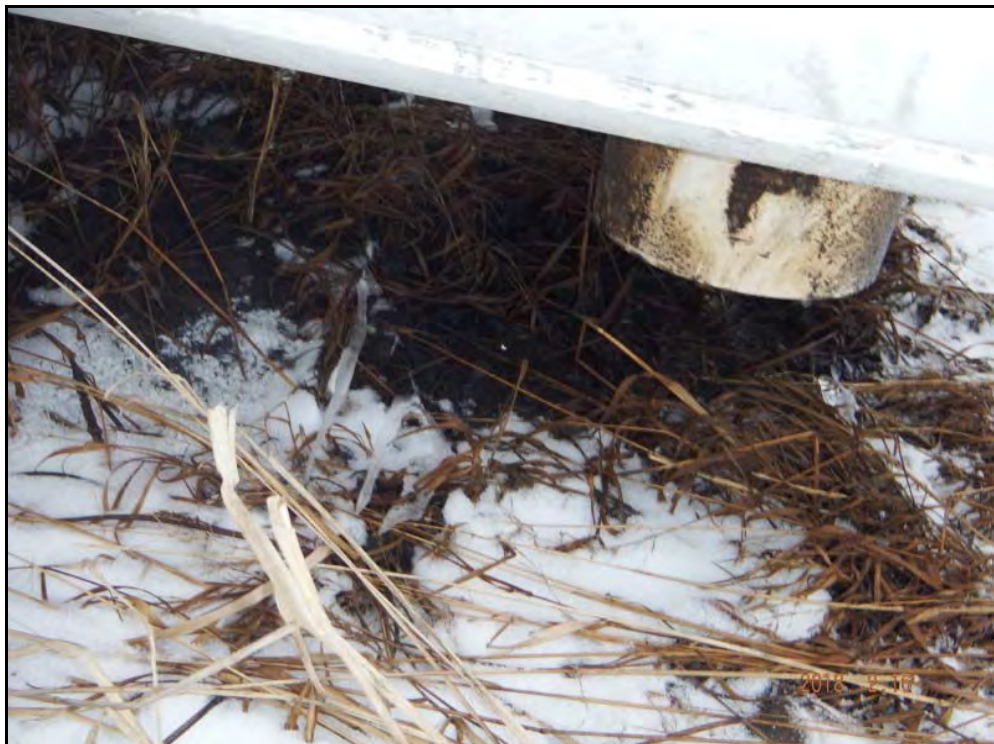
Photograph 24: Staining observed beneath the UN#1863 tank.

A small dark surficial stain was observed on the grassed area beneath the UN#1863 (fuel, aviation, turbine engine) tank located near the northeast corner of the Property (Photographs 23 and 24). It is recommended that the stained soil be removed and disposed of properly. If staining extends beyond 300 mm, soil sampling is recommended. It is also recommended that a drip tray or secondary containment unit be installed beneath the tank.

- A small dark surficial stain was observed on the grassed area beneath the UN#1863 (fuel, aviation, turbine engine) tank located near the northeast corner of the Property. It is recommended that the stained soil be removed and disposed of properly. If staining extends beyond 300 mm, soil sampling is recommended. It is also recommended that a drip tray or secondary containment unit be installed beneath the tank. The tank should also be registered with the PTMAA.

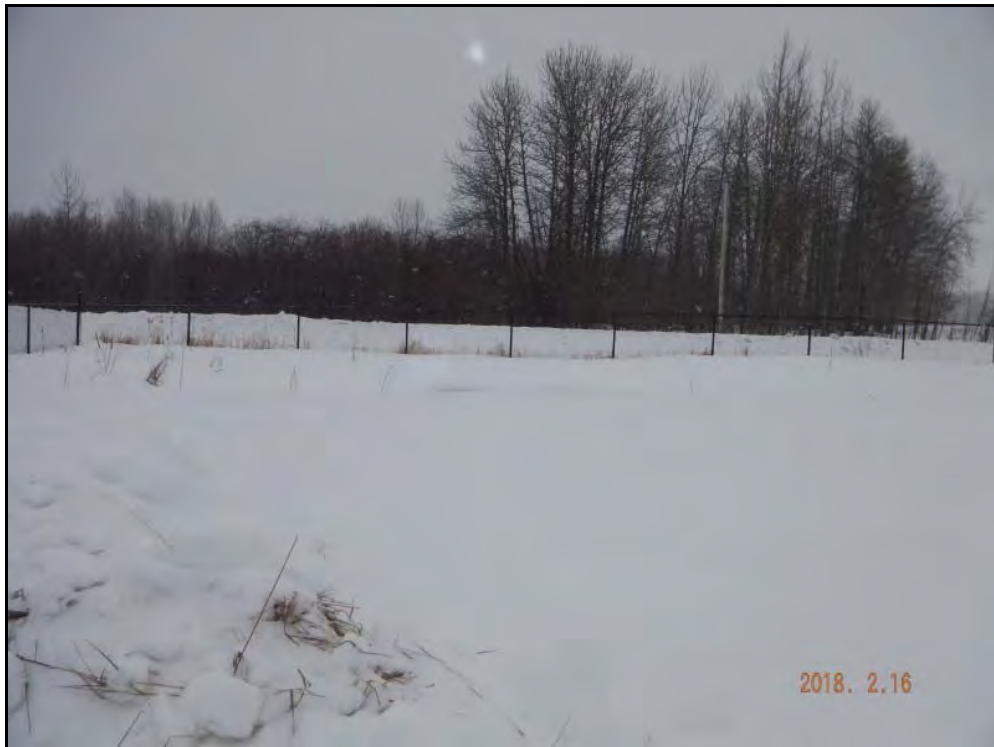
Photograph 25: Fire suppression pond located in the northeast corner of the yard.

A pond was observed near the northeast corner of the yard (Photograph 25). Mr. Friesen stated that the pond was installed as per government requirements for fire suppression.

The Property was relatively flat. No standing water was observed on the Property at the time of the assessment, however, the inspection was limited due to snow coverage. Mr. Friesen stated that a seasonal creek was present across the southern side of the Site. A pond had been installed on the northeast corner of the Property as per government requirements for fire suppression (Photograph 25).

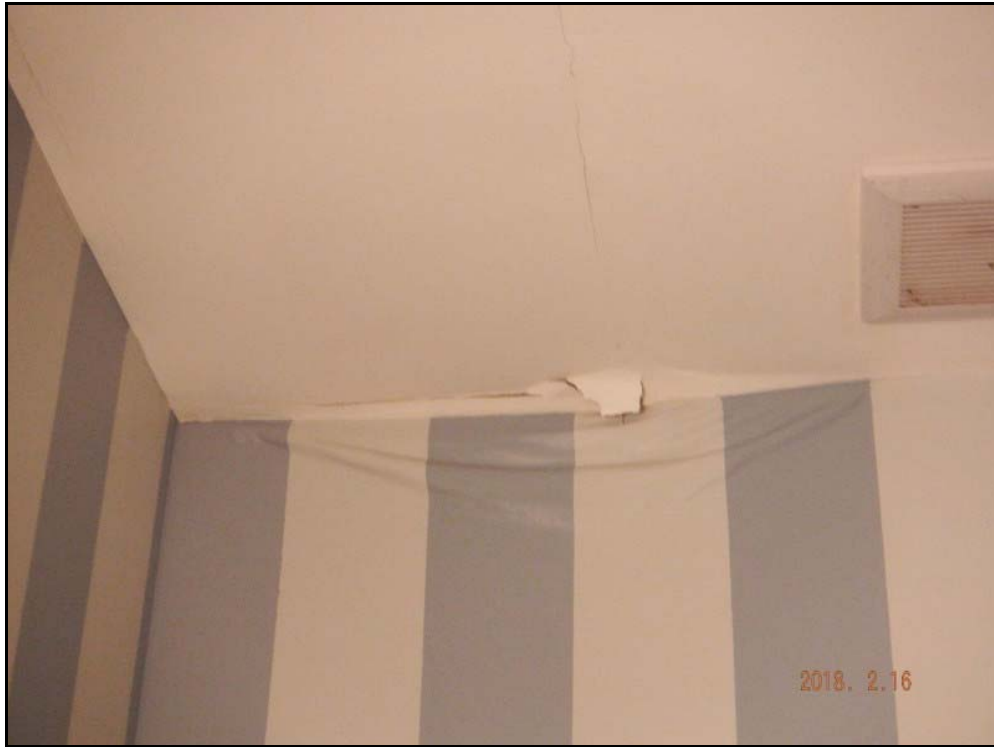
Photograph 27: Water damage observed in the main floor bathroom.

No signs of air emissions or air quality were observed on the Property at the time of the assessment. A small area of water damage was observed on the ceiling in the main floor bathroom (Photograph 27). Mr. Friesen stated that the water damage was caused by condensation from the hot water tank located directly above the bathroom.

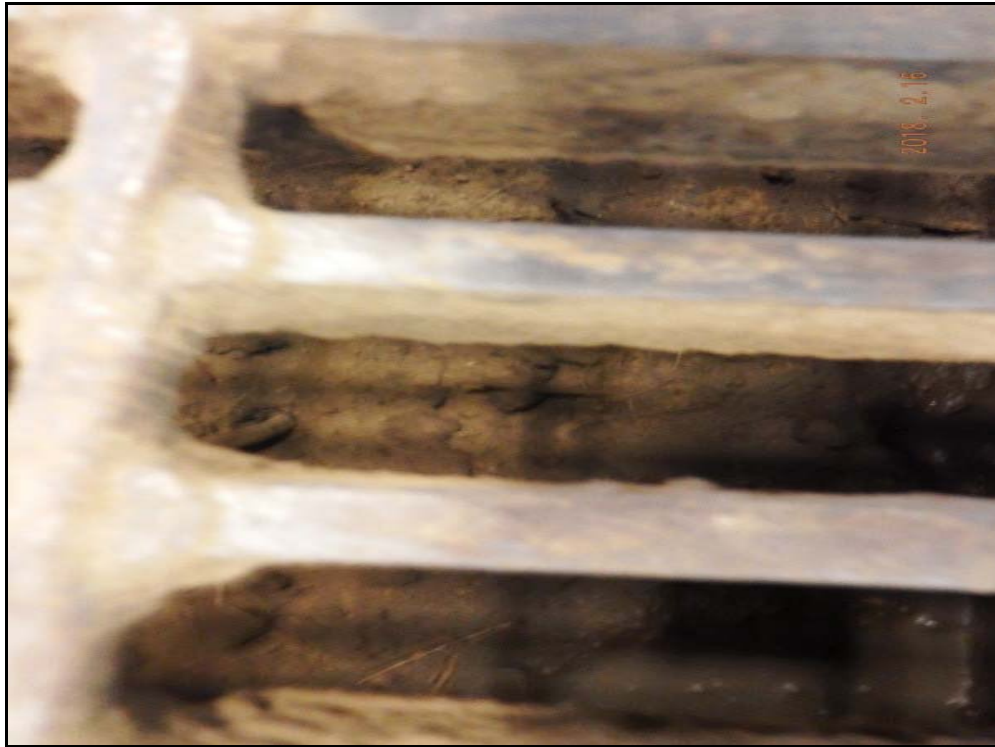
Photograph 37: View of dry drain system observed within the shop.

A dry drain and sump were observed within the building. The sump appeared to be in good condition (Photograph 37). Mr. Friesen stated that the drain and sump were connected to the septic tank which was emptied on an as needed basis.
